**REPORT NUMBER: 301-MGA-2008-006**

**SAFETY COMPLIANCE TESTING FOR FMVSS 301R  
FUEL SYSTEM INTEGRITY – REAR IMPACT**

**GENERAL MOTORS CORPORATION  
2008 TAHOE HYBRID  
NHTSA NUMBER: C80111**

**PREPARED BY:  
MGA RESEARCH CORPORATION  
5000 WARREN ROAD  
BURLINGTON, WI 53105**

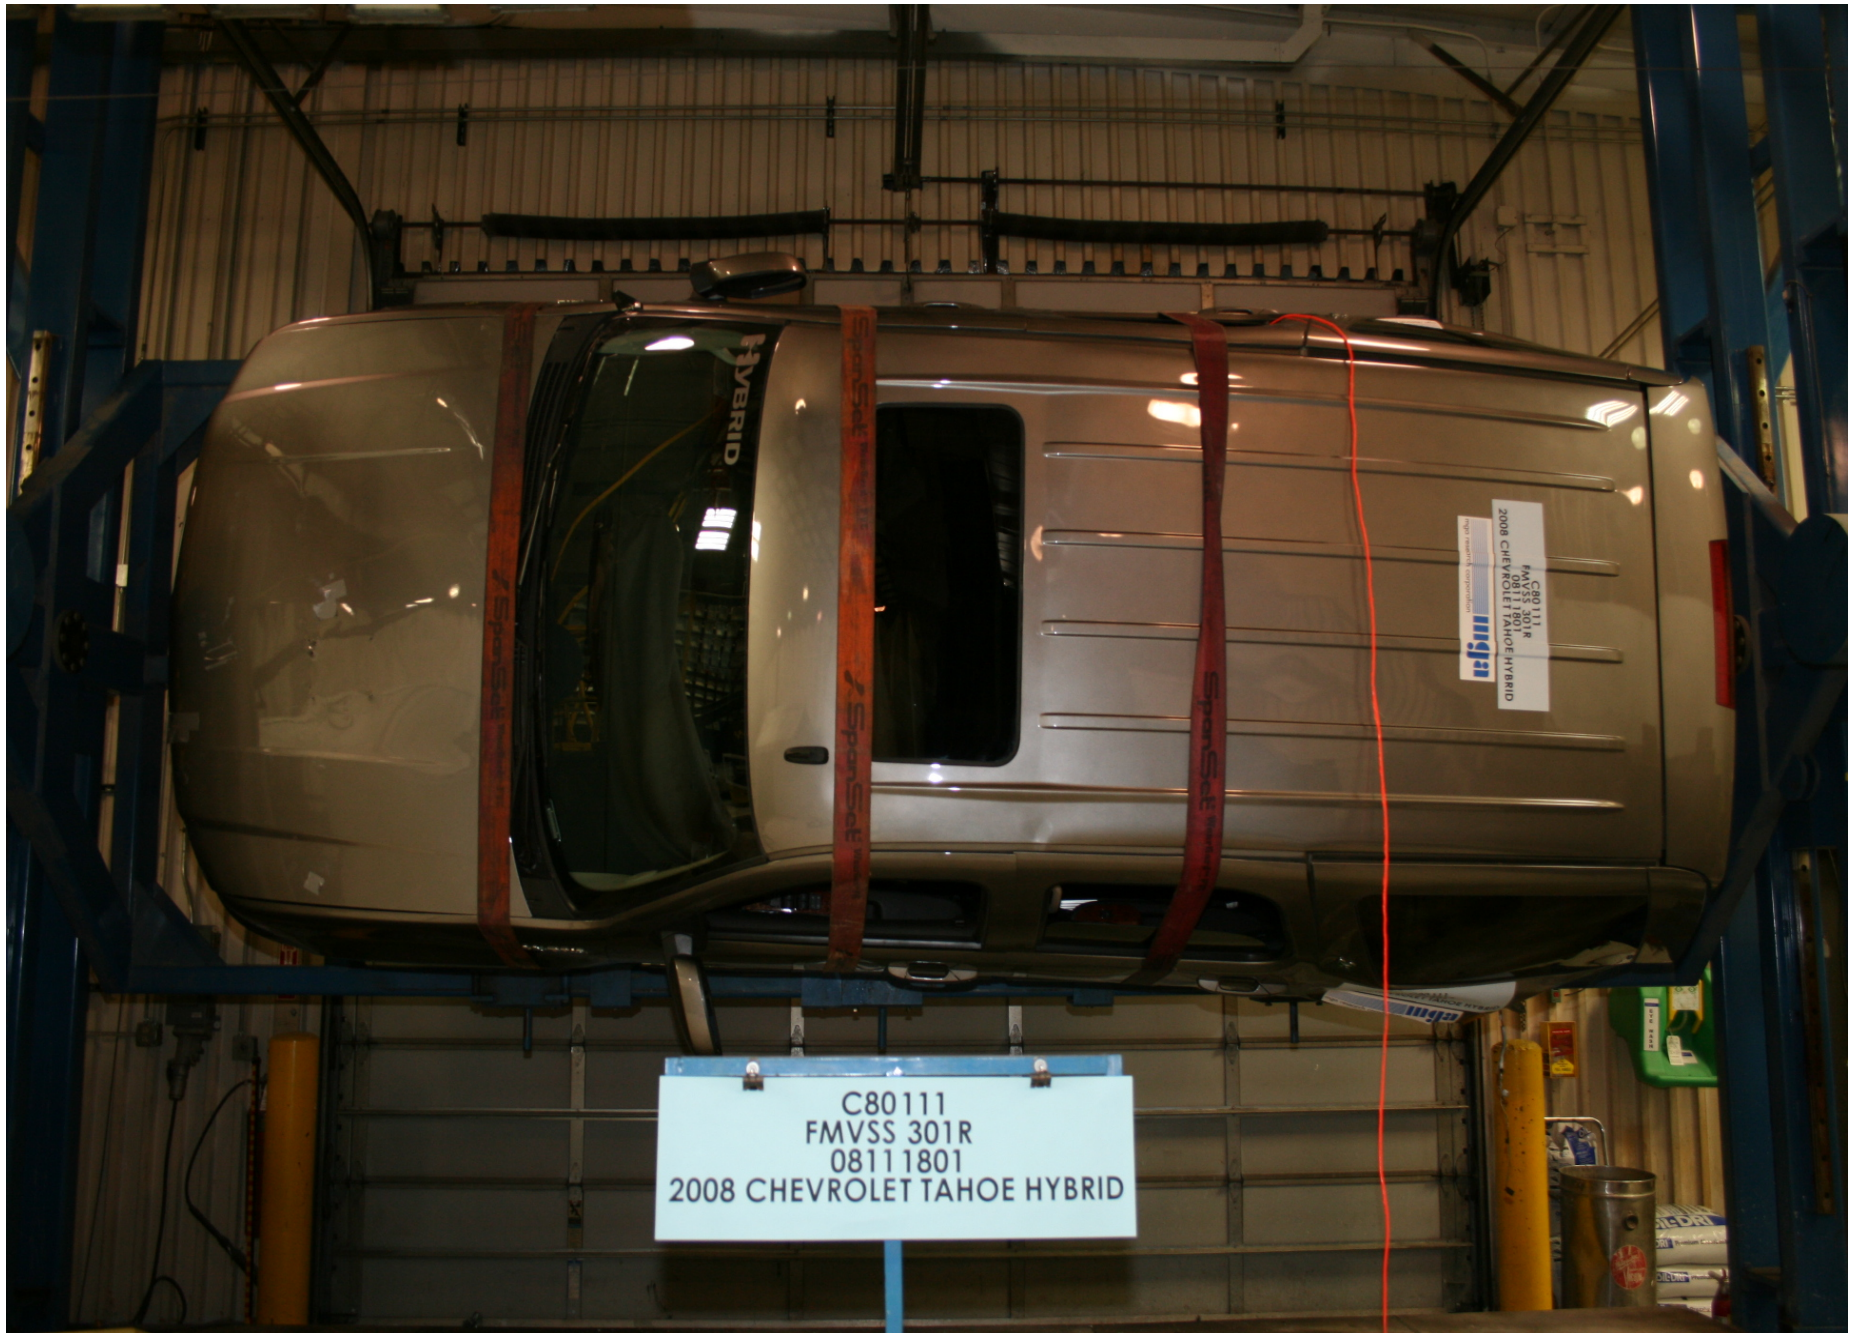
There was no Stoddard Solvent or electrolyte leakage after the event or during any phase of the static rollover.

Static Rollover at 90 Degrees

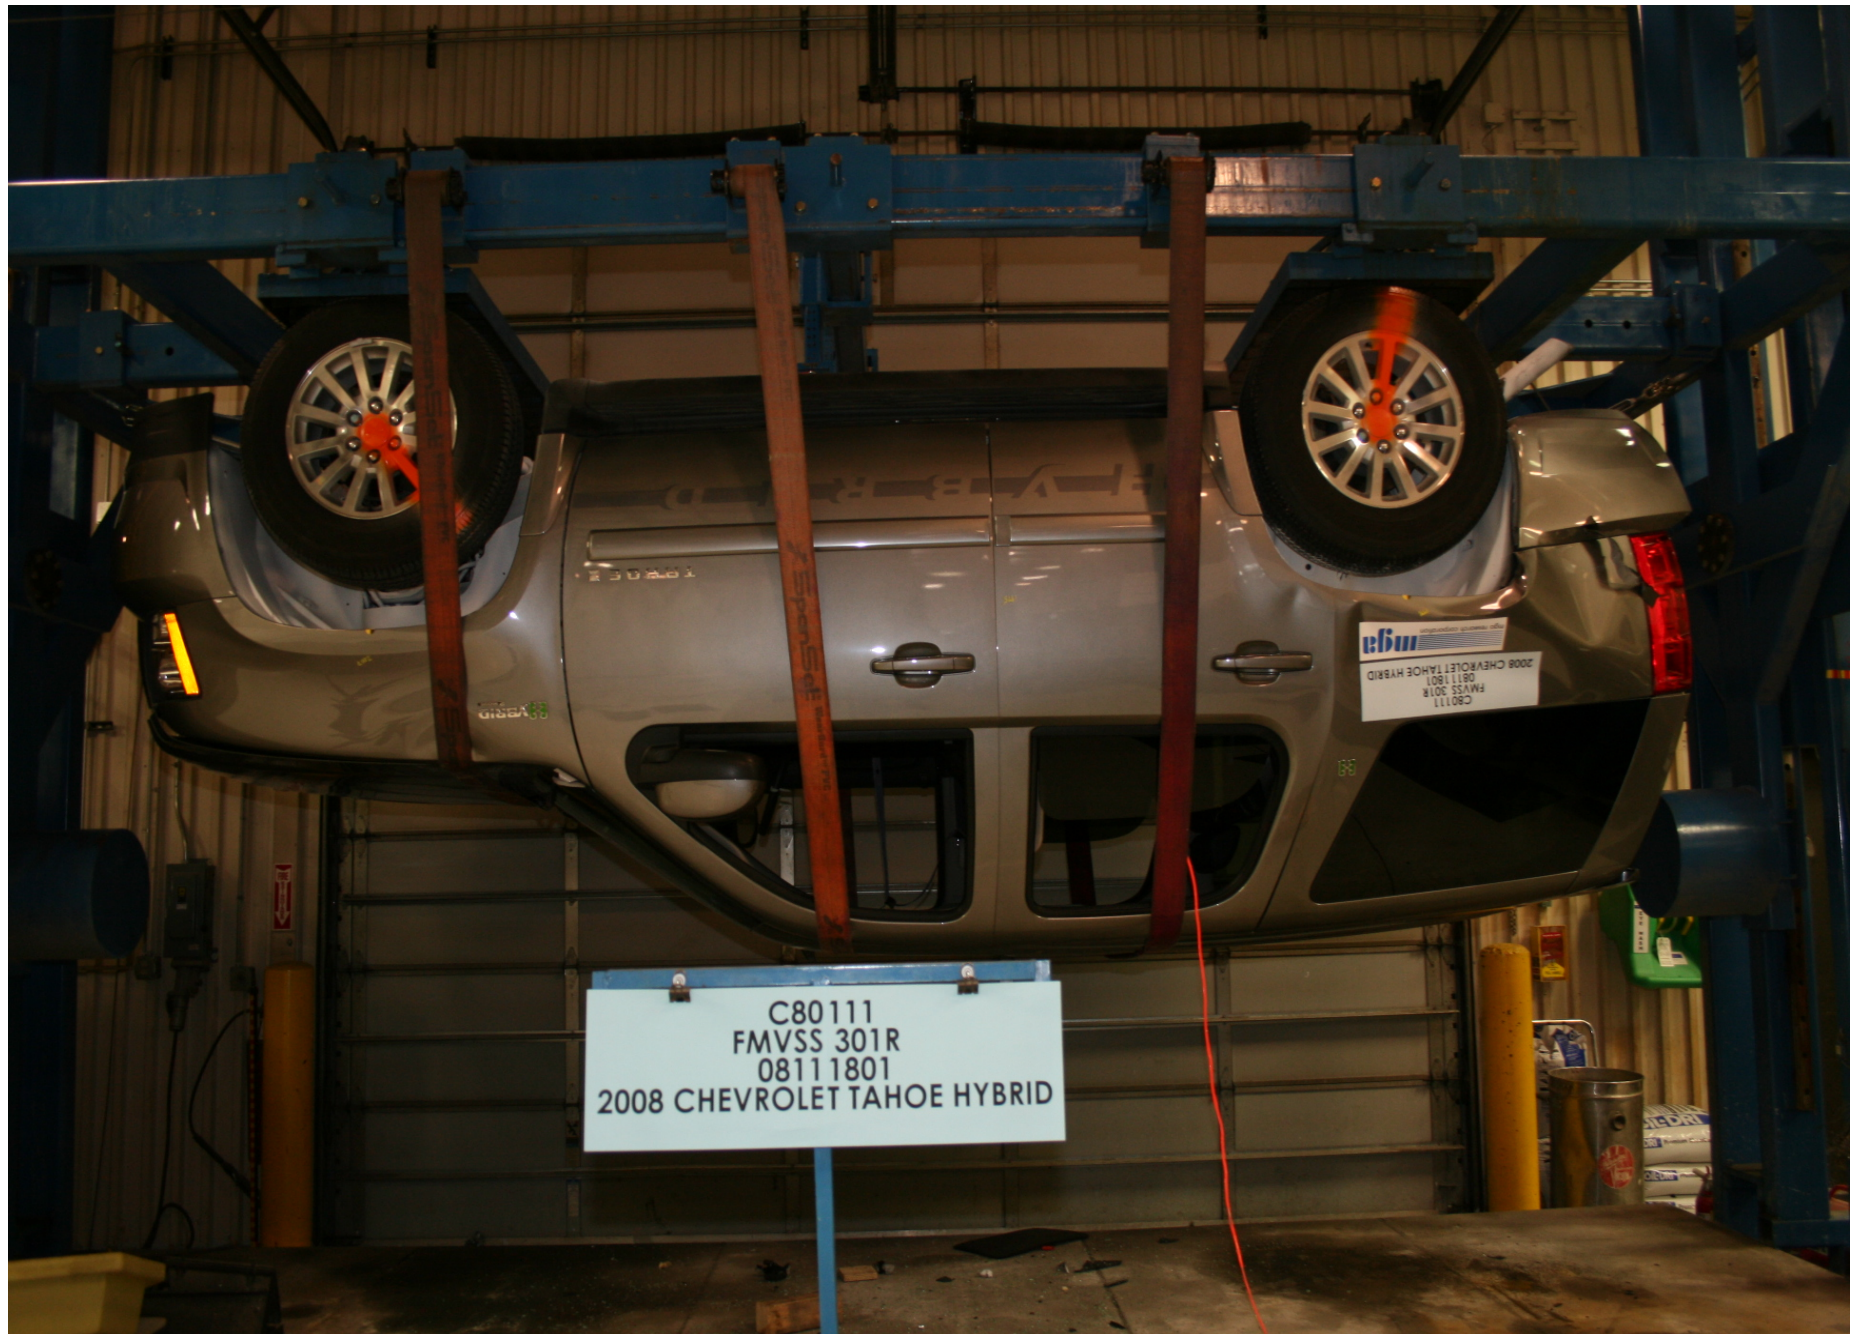
Static Rollover at 180 Degrees

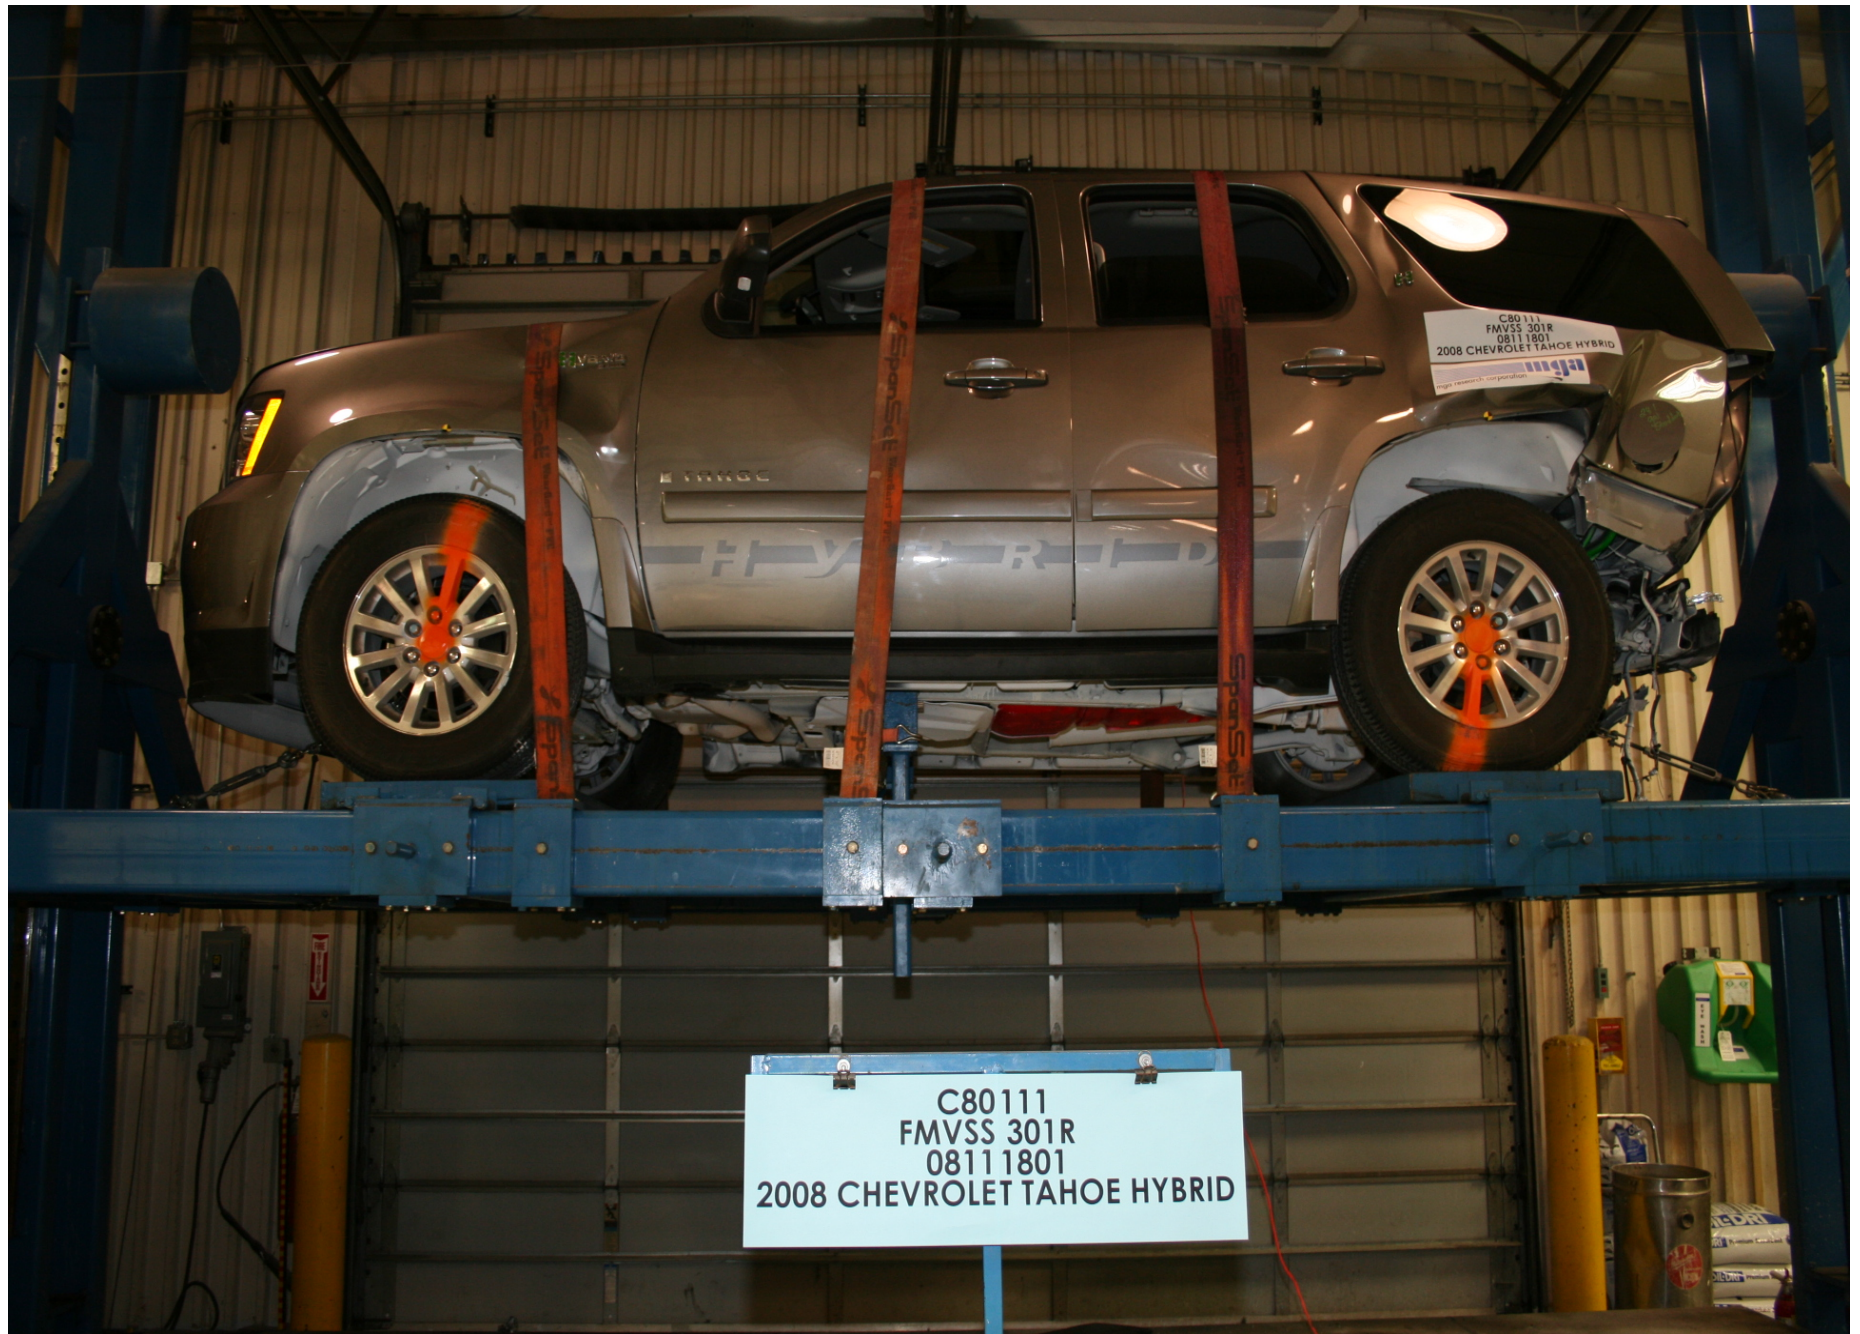
Static Rollover at 360 Degrees

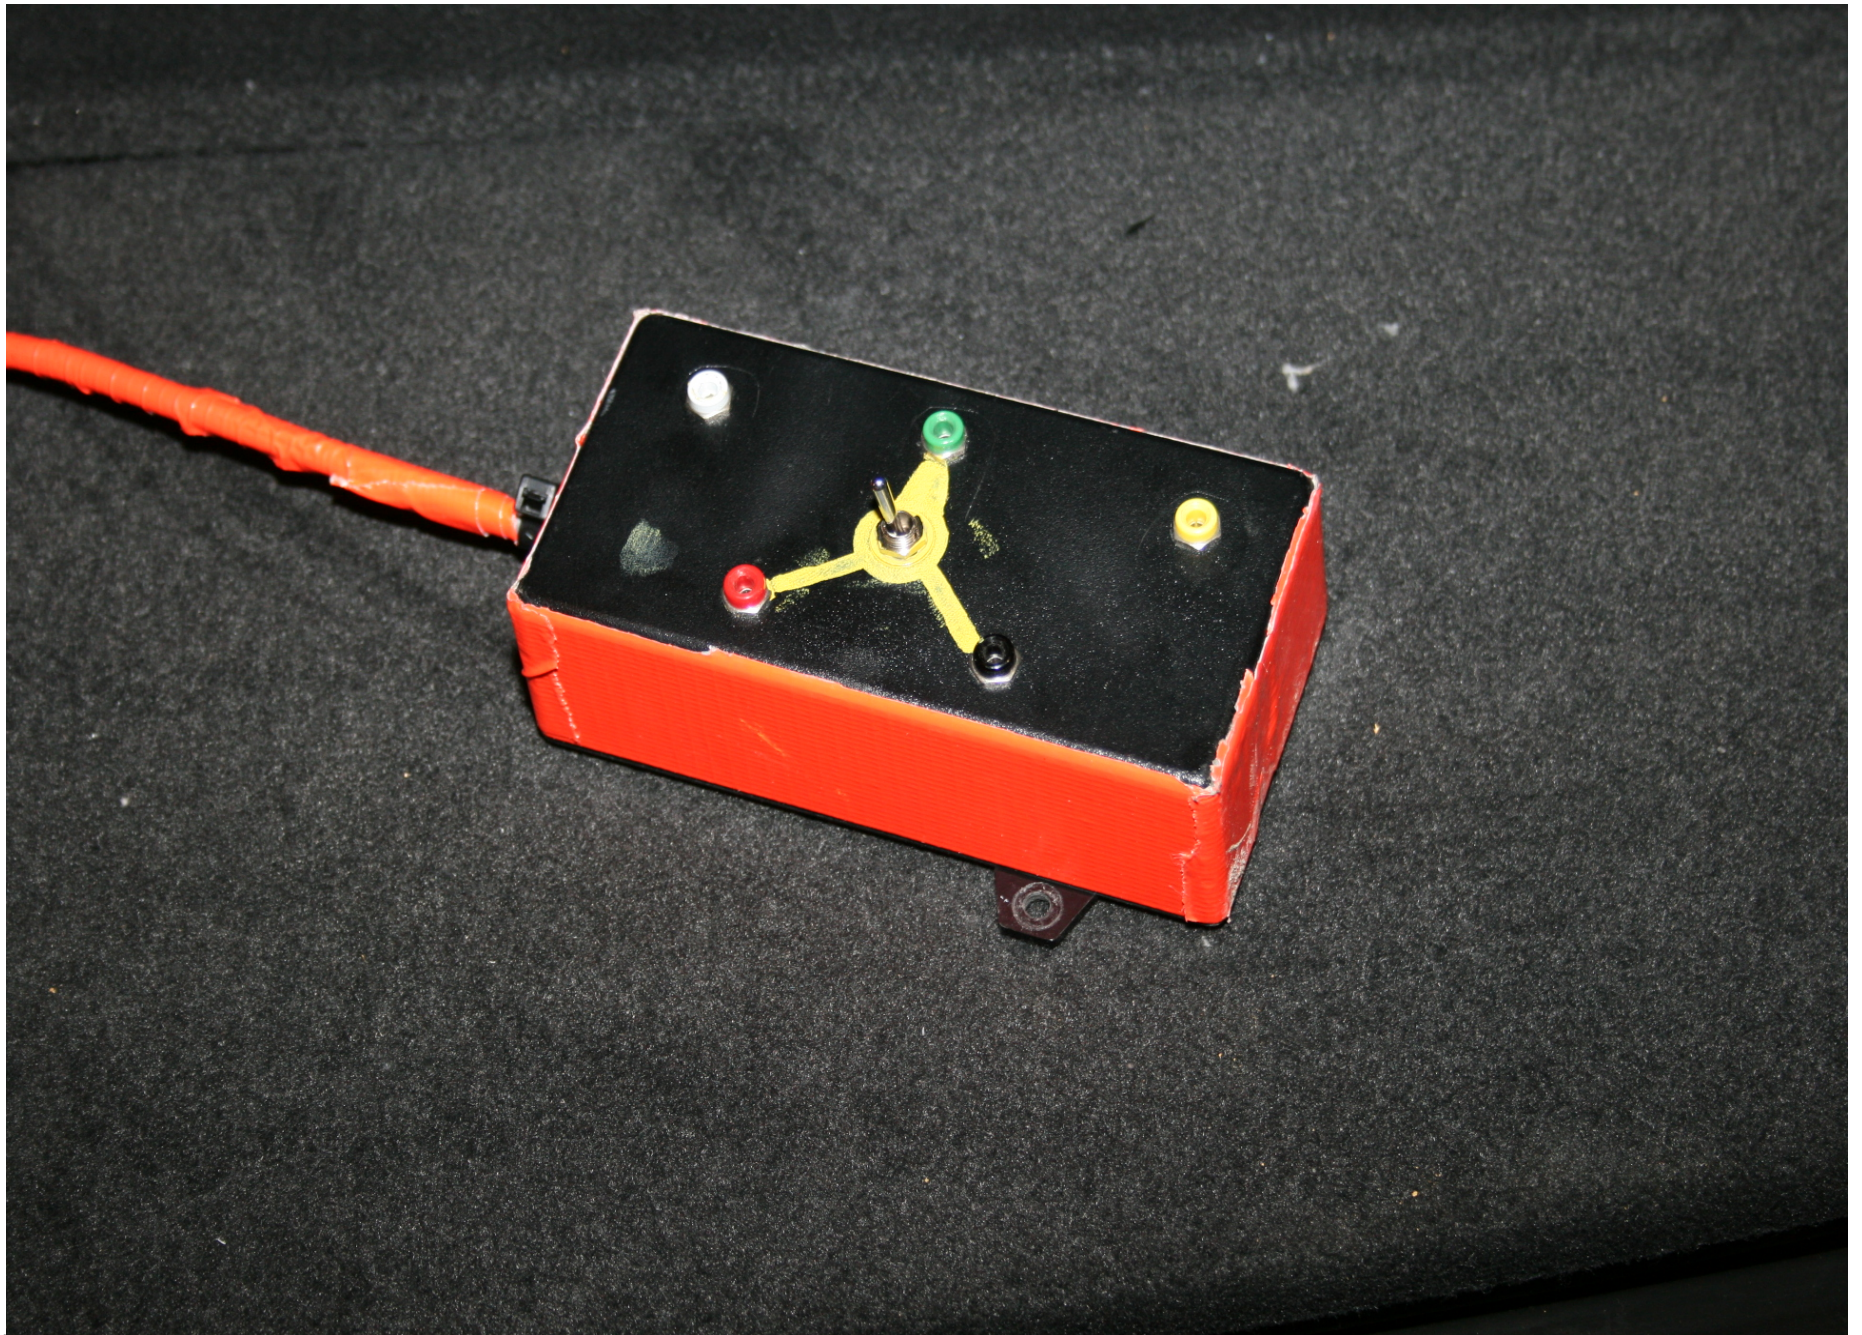
B-39.

Pre-Test High Voltage Interconnect

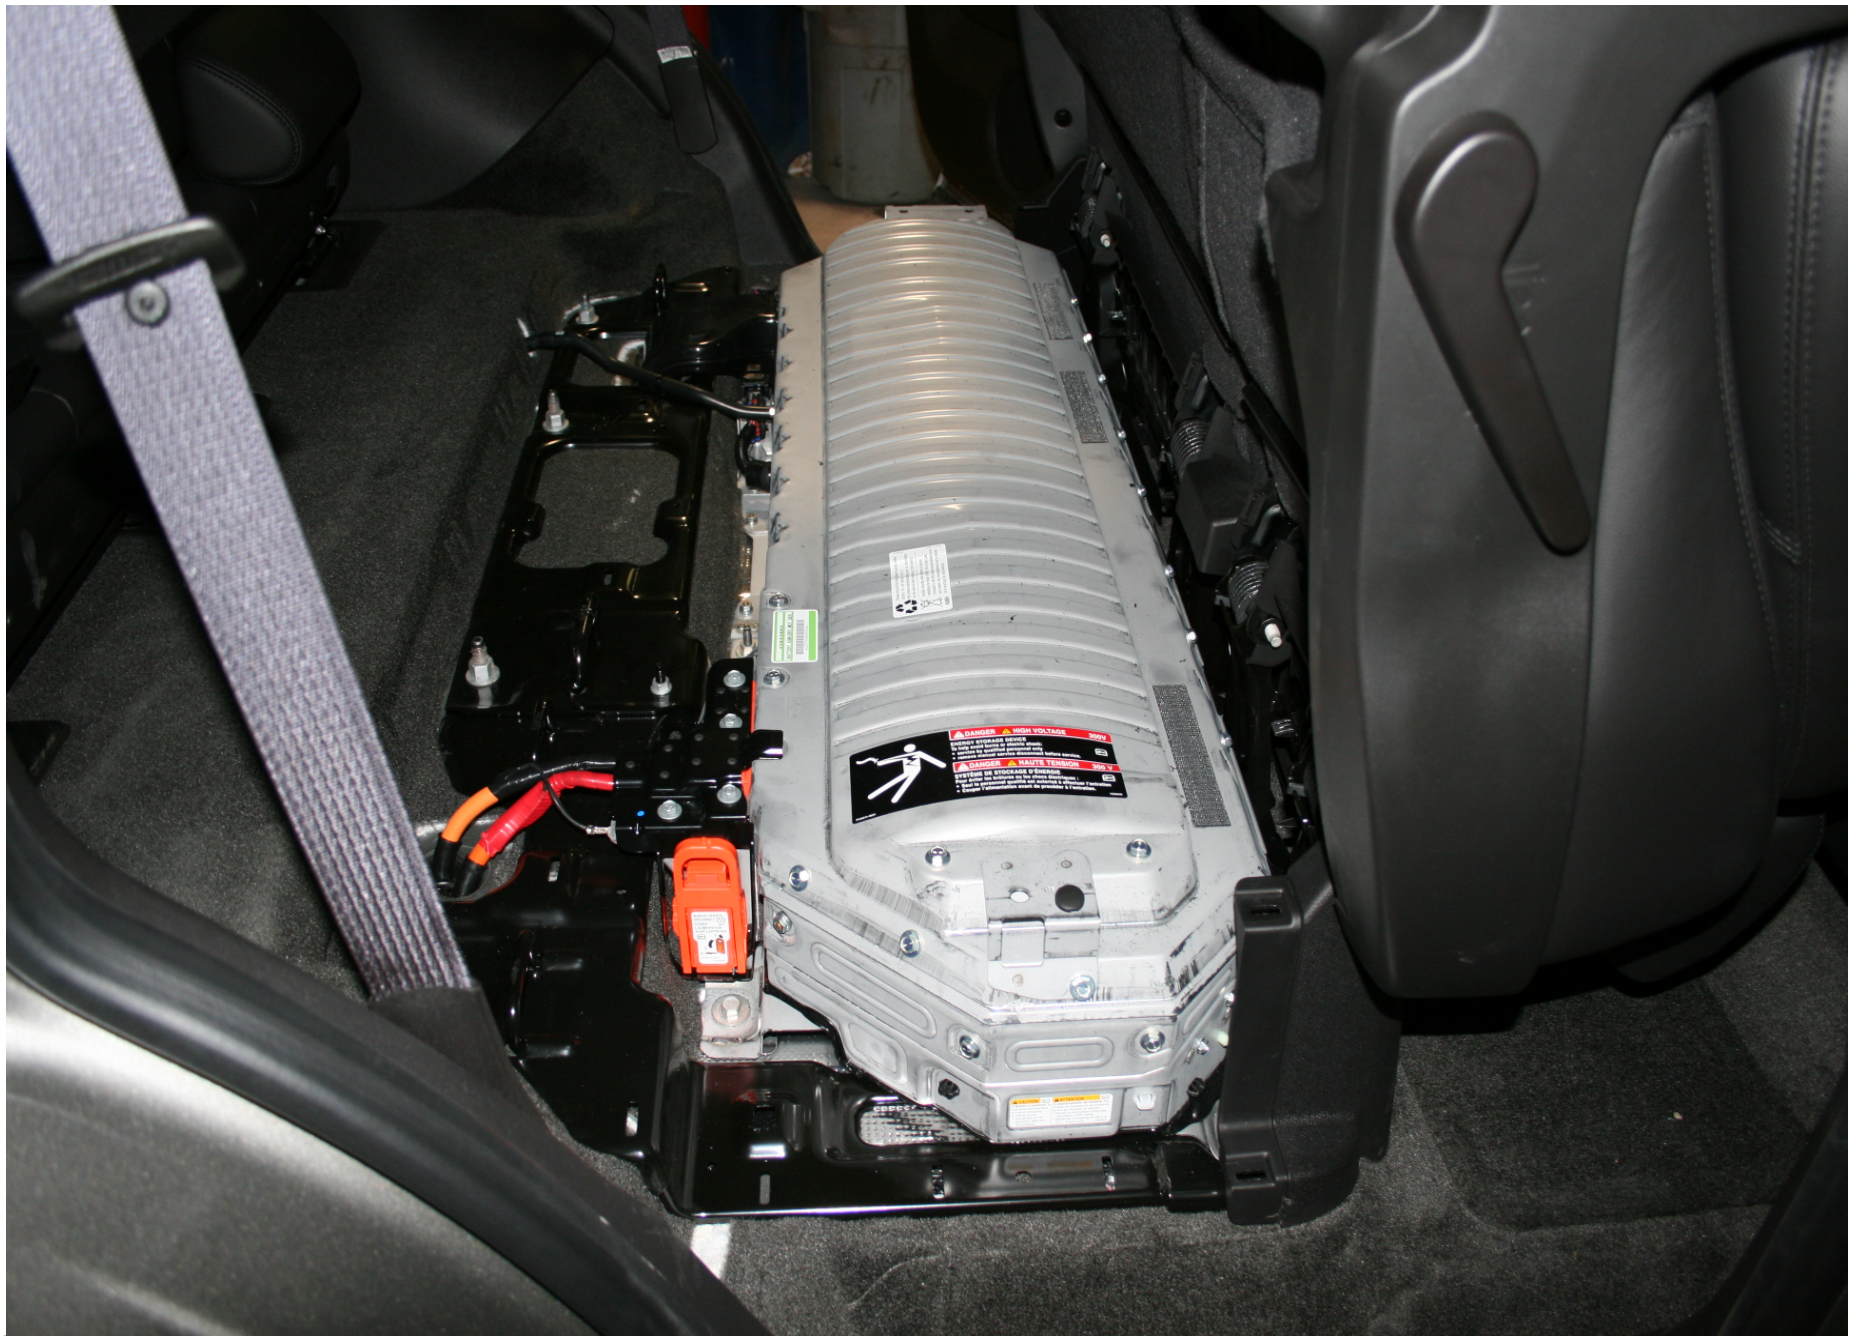
B-40.

Pre-Test Installed Test Interface Port

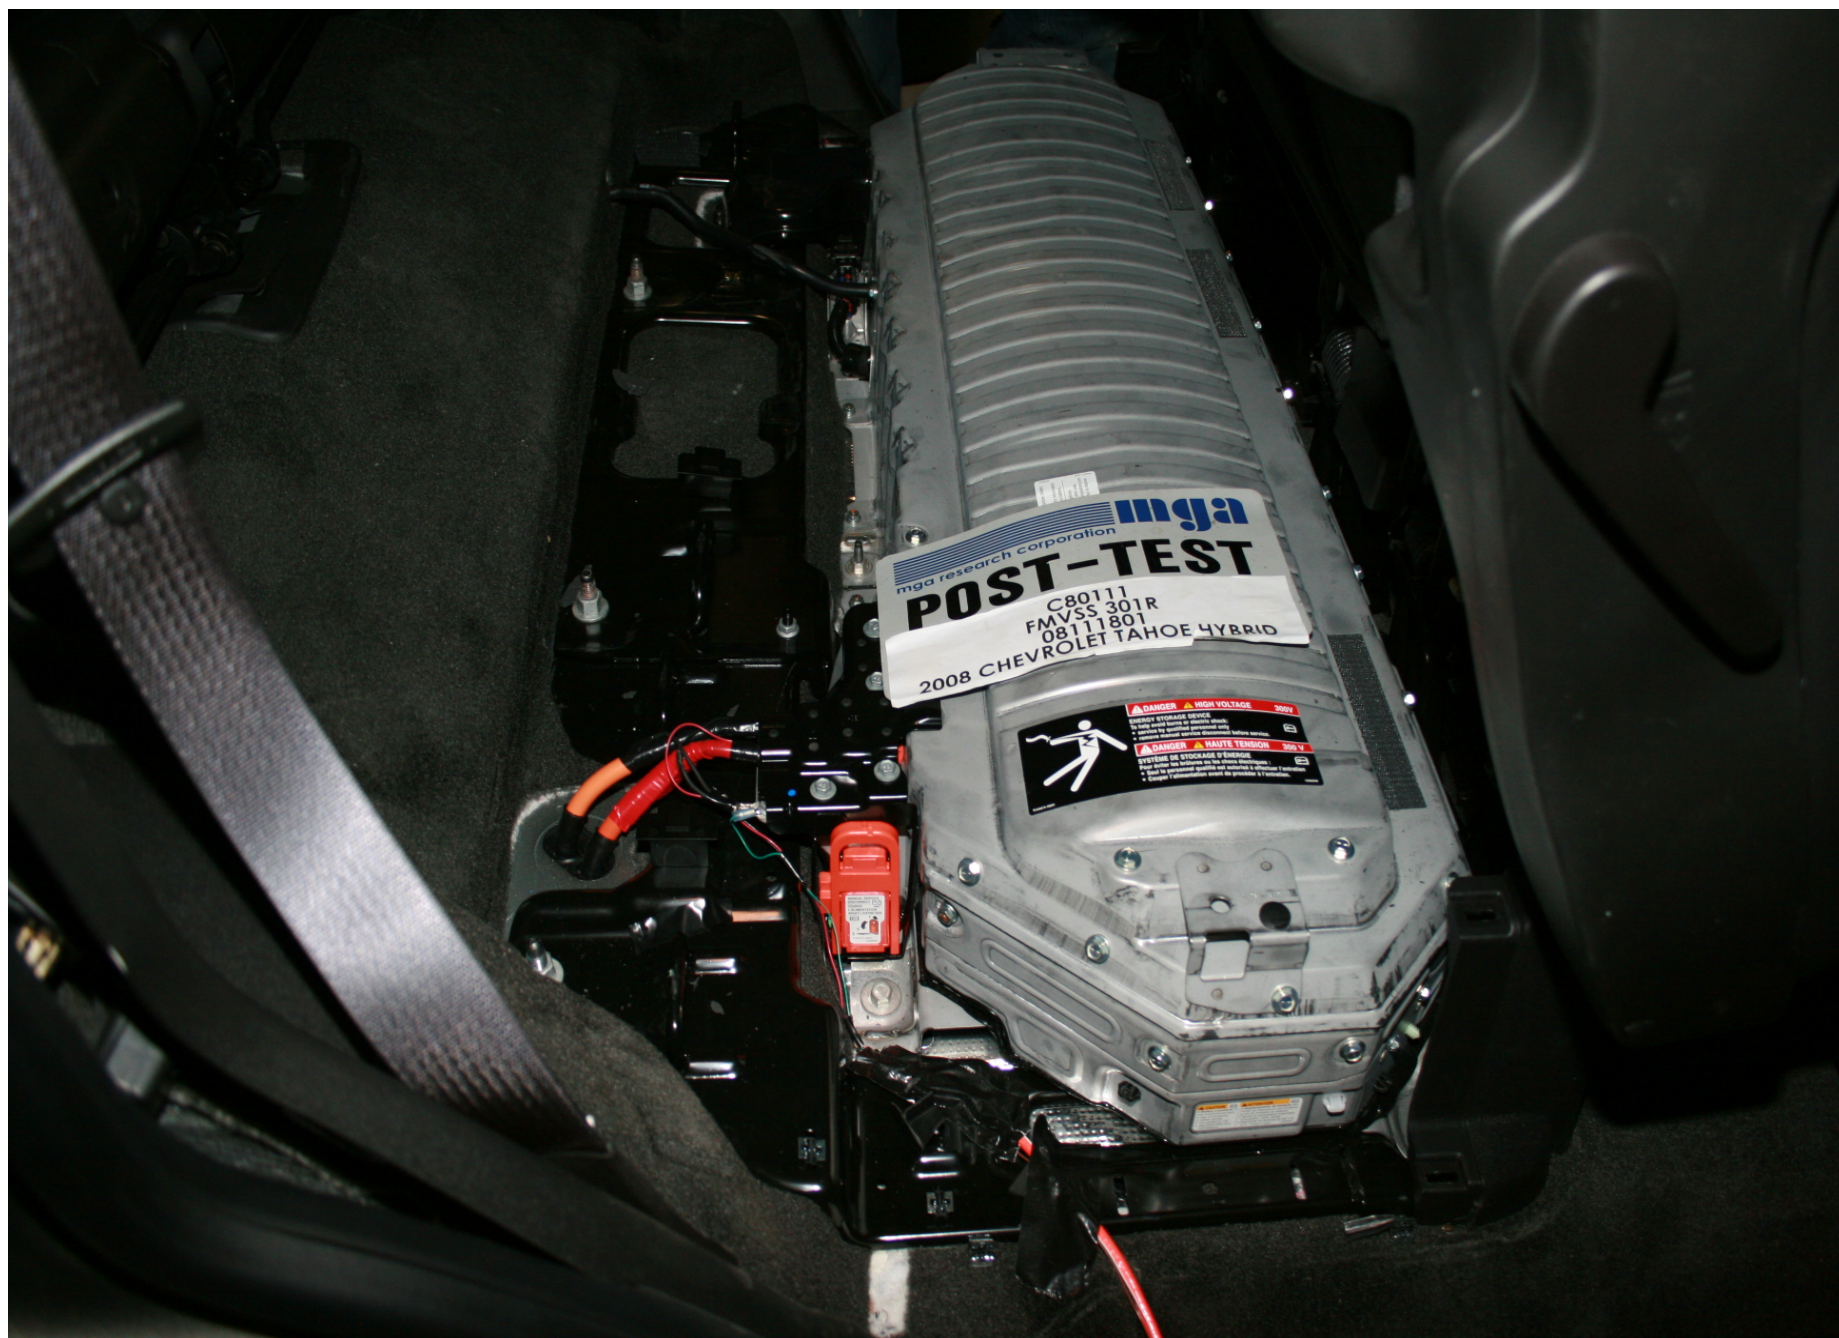
Pre-Test Vehicle Pass. Compartment Adjacent to Propulsion Battery

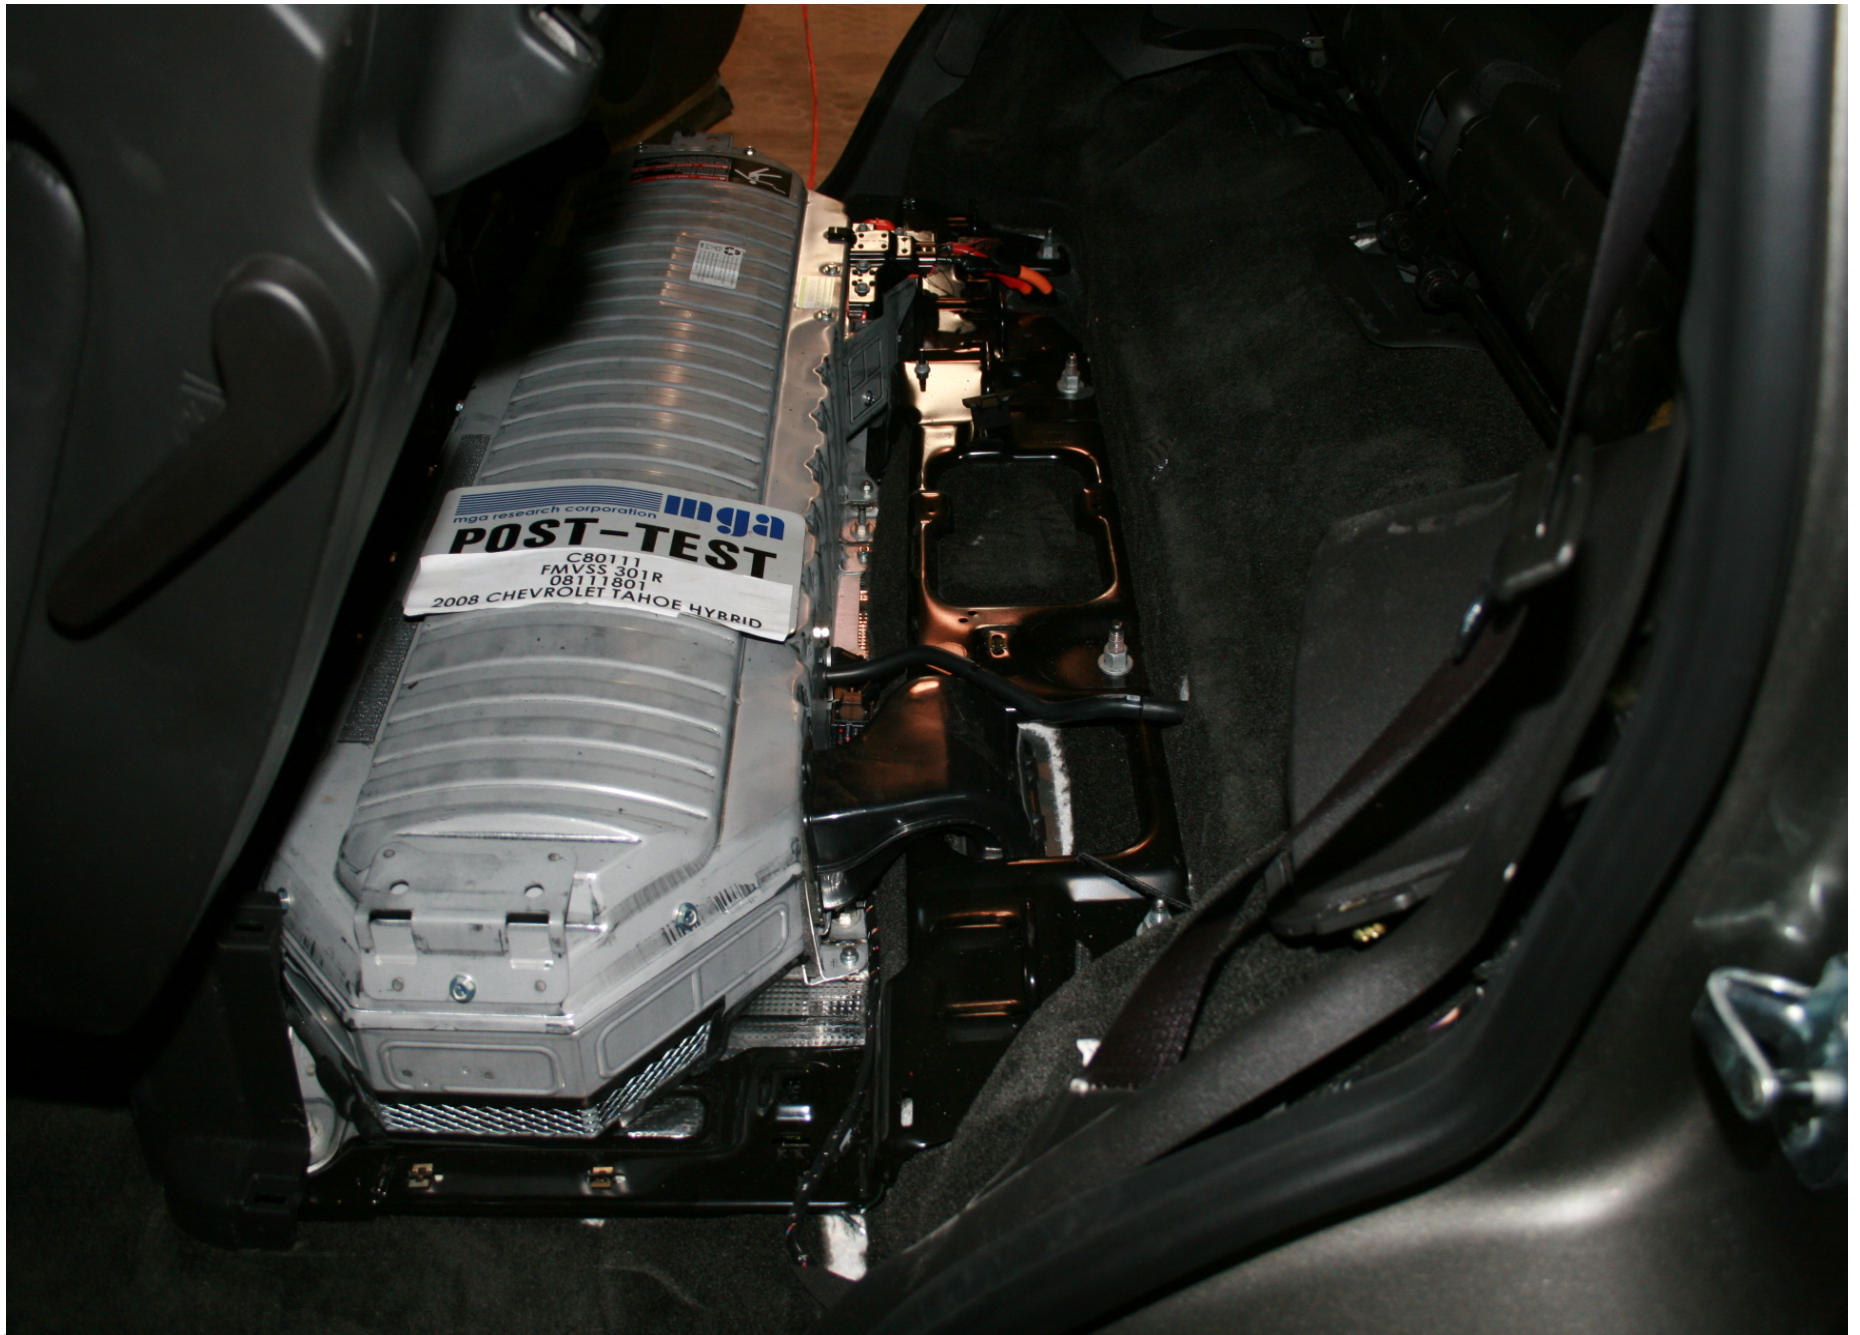
Post-Test Vehicle Pass. Compartment Adjacent to Propulsion Battery

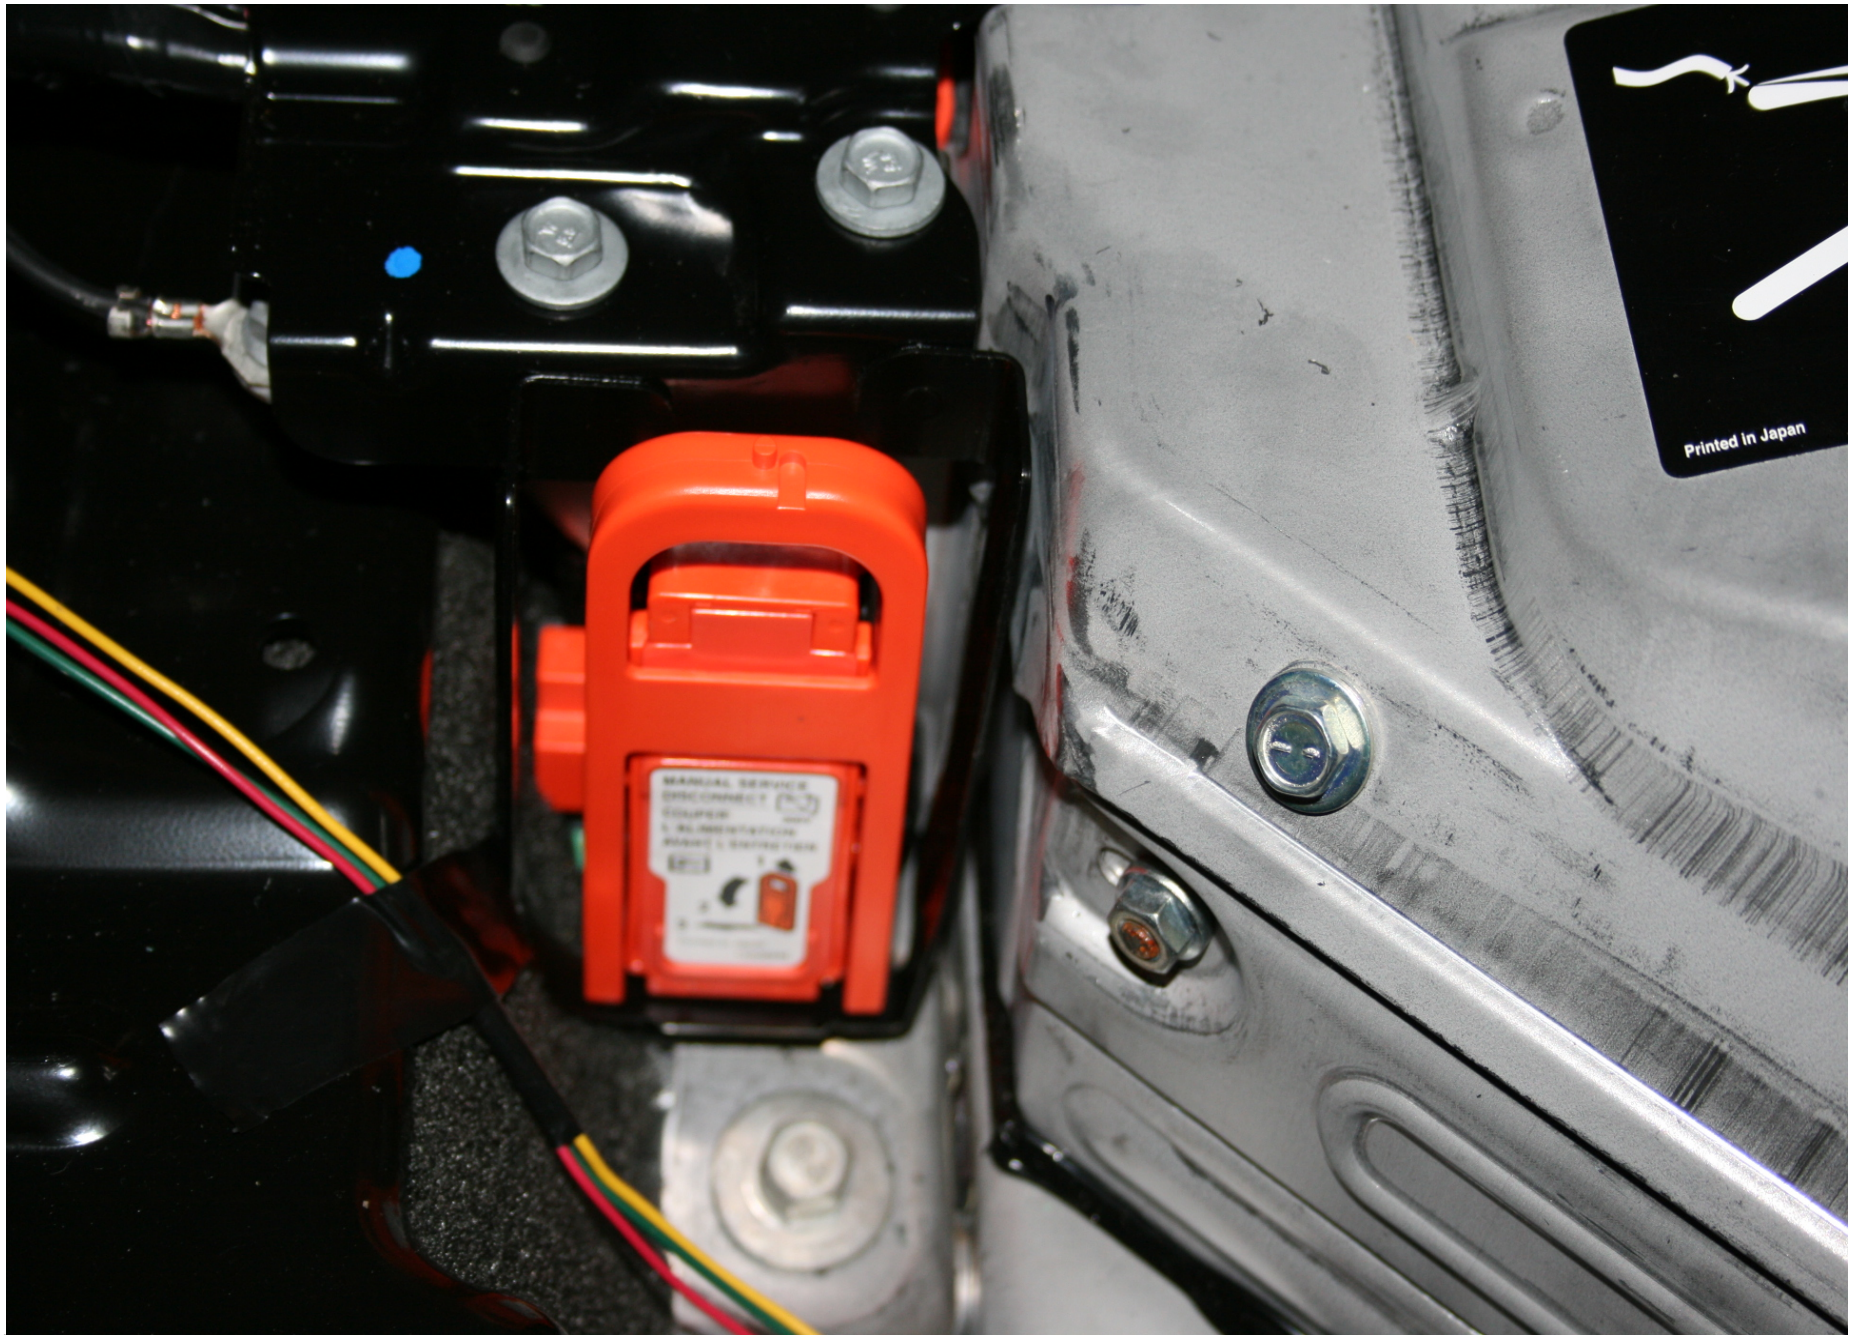
B-45.

| Details of Propulsion Battery Components [Supply photographs as appropriate]: | High voltage service disconnect located at right rear battery pack. See photo B-44. |

Pre-Test Service Switch Disconnect

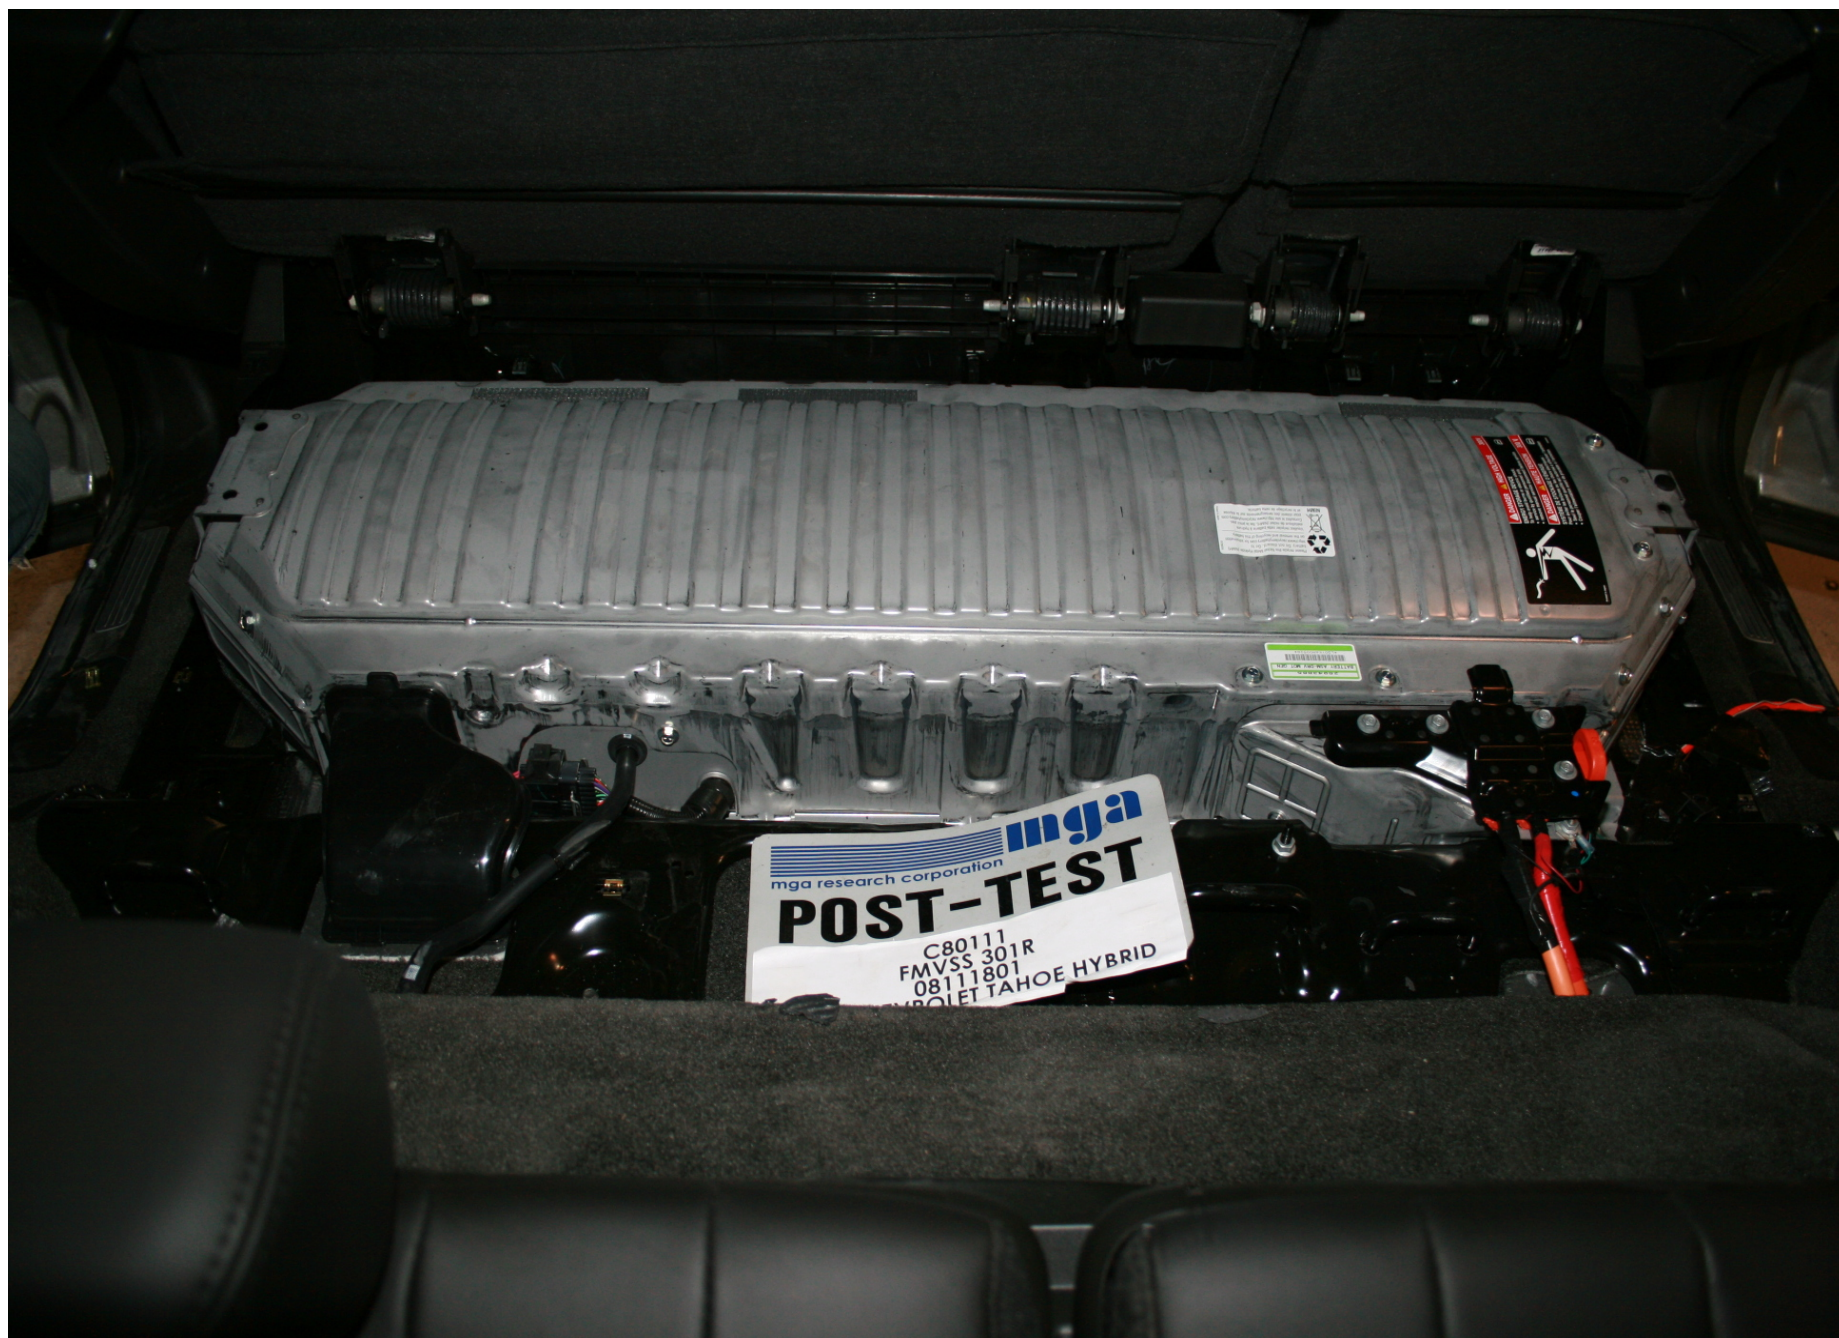
Post-Test Propulsion Battery Module View 1
